**Inspection Report for  
Apple Valley Heights CWD  
Apple Valley, CA**

**15KG Steel On-Grade  
West Tank**

**Date Completed: March 7, 2015**

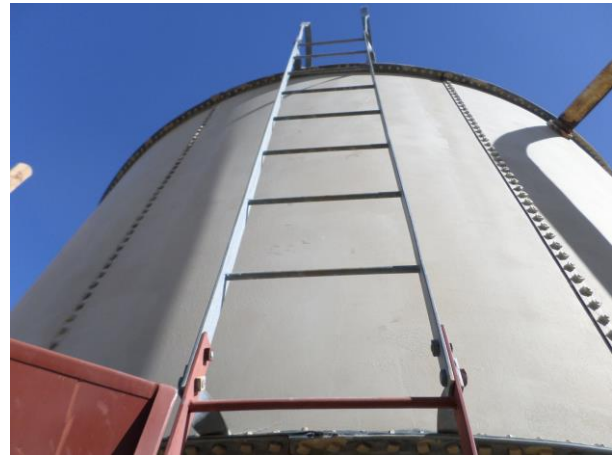
Summary: The galvanized ladder was found secure, OSHA approved and in good condition with oxidation and 2% corrosion noted.

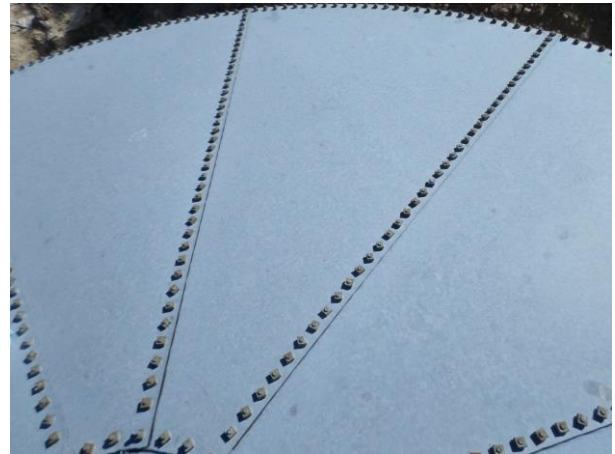
Summary: The roof was found in good condition with 3% surface corrosion noted.

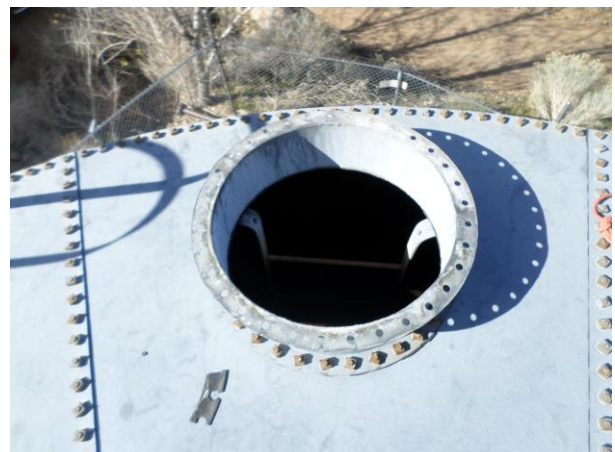
Summary: The hatch was found bolted shut with a partial gasket present and in good condition with oxidation noted.

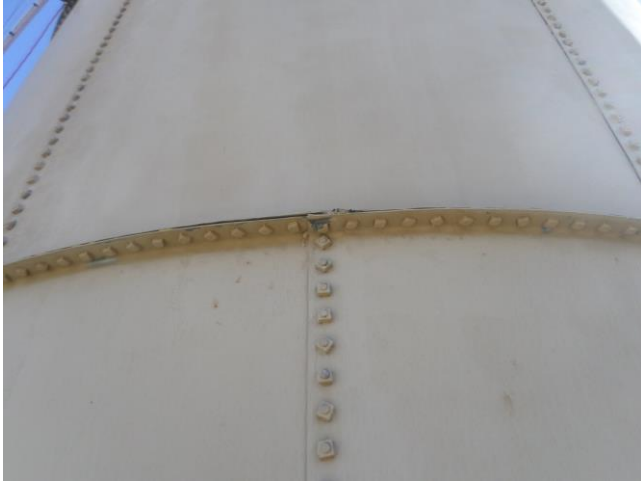
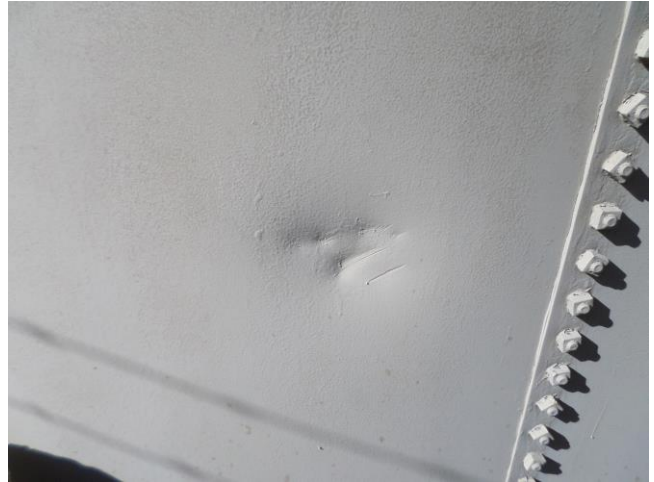
Summary: The wall was found in good condition with dents and less than 1% surface corrosion noted.

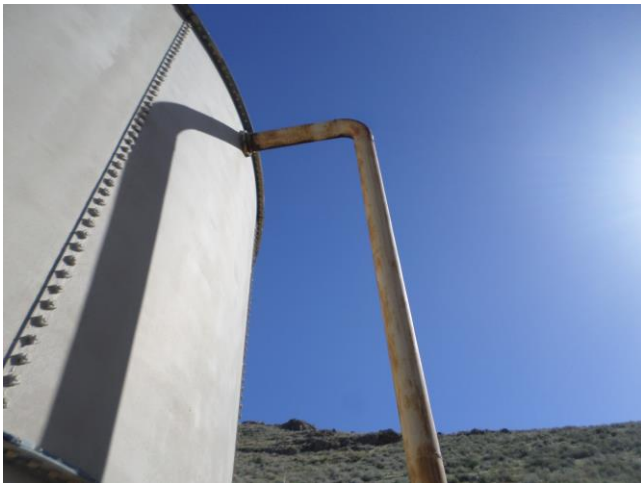
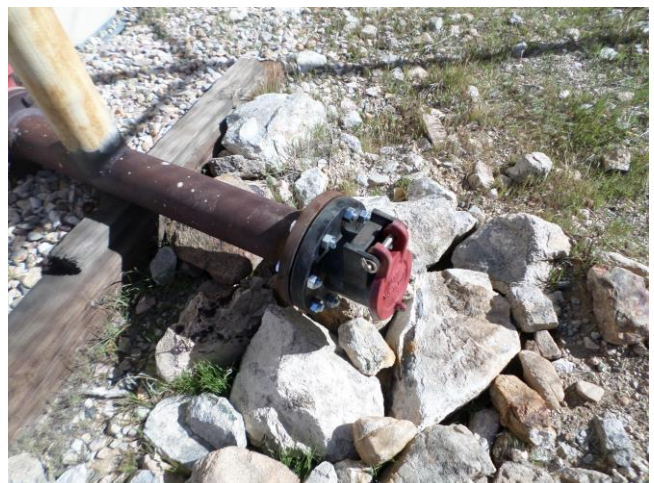
Summary: The overflow was found in good to fair condition with oxidation and 50% surface corrosion noted.

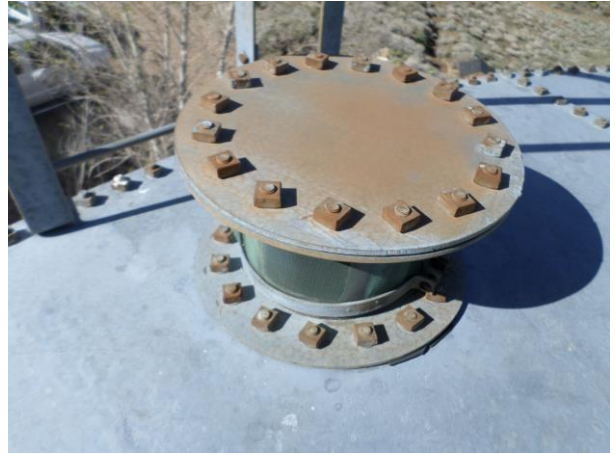
Summary: The galvanized vent was found in good condition with oxidation and 40% surface corrosion noted and a screen in place.

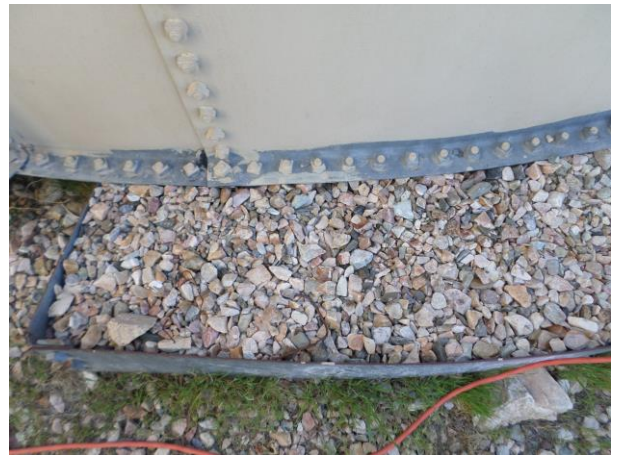
Summary: The base of the tank was found in good condition.

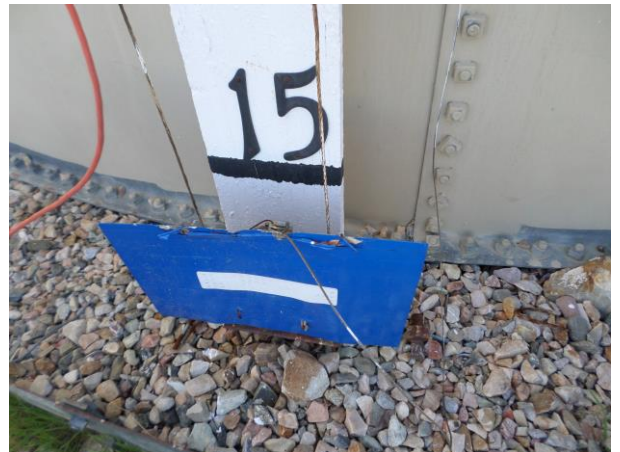
Summary: The cable on the float level indicator was found broke and not functioning.

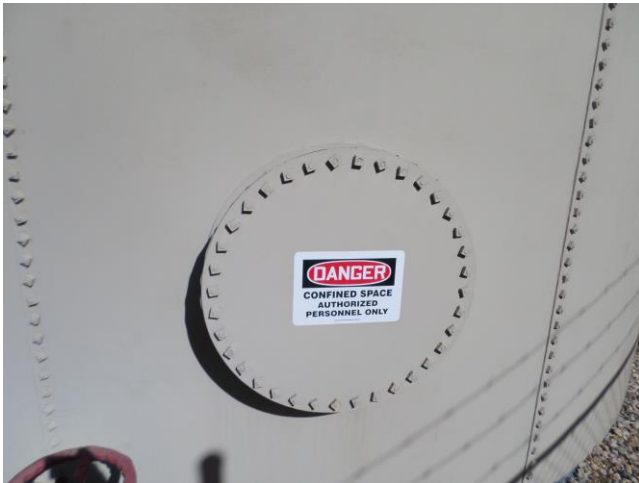
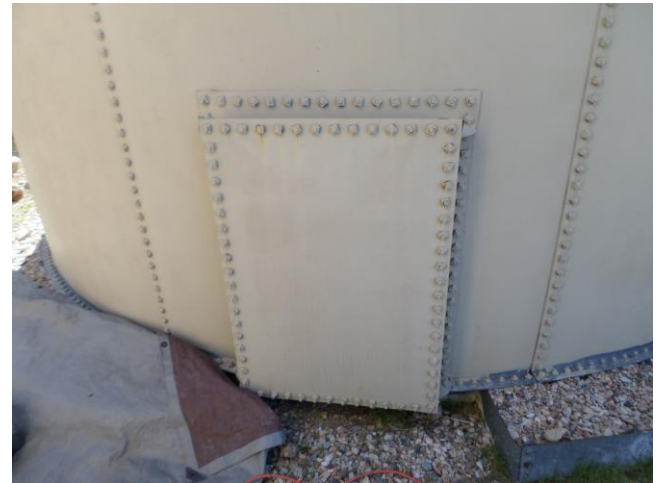
Summary: The manways were found secure and in good condition with less than 1% corrosion noted.

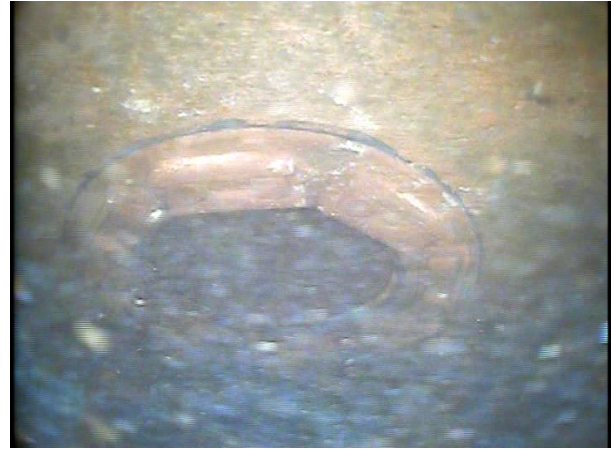
Summary: The galvanized common inlet/outlet was found in good to fair condition with 100% surface corrosion noted.

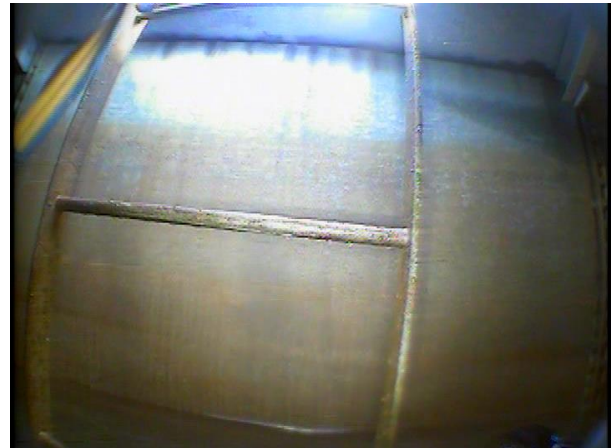
Summary: The galvanized ladder was found secure and in good condition with 5% surface corrosion noted.

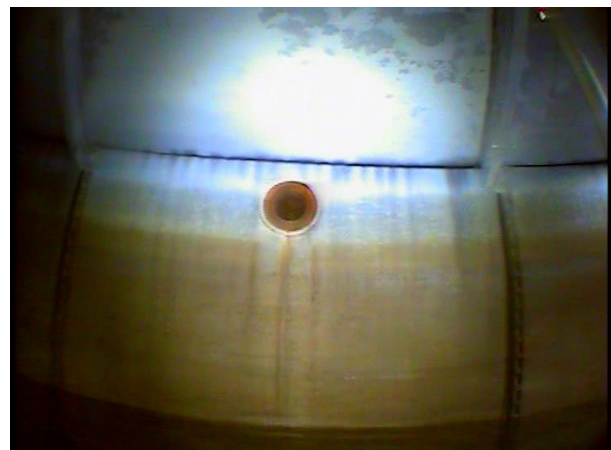
Summary: The overflow was found in good to fair condition with 100% surface corrosion noted.

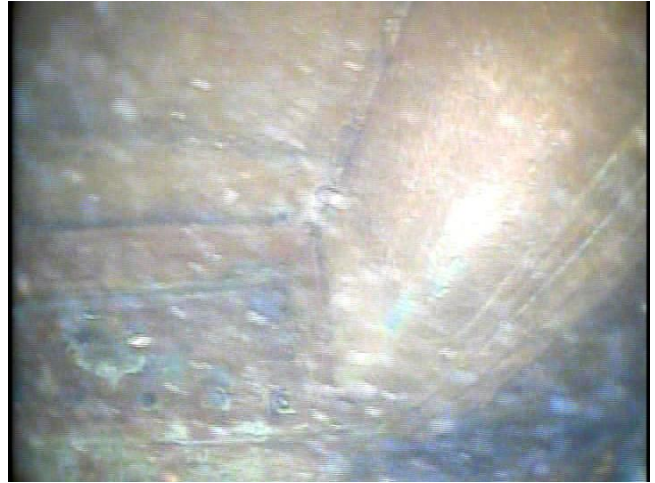
Manway 2 close-up

Summary: The galvanized manways were found in good condition with heavy staining and 3% surface corrosion noted.

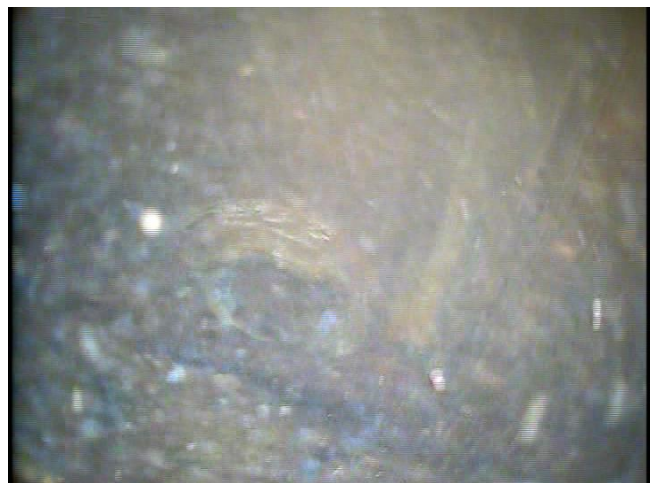
Summary: The drain was found in good to fair condition with 100% surface corrosion noted.

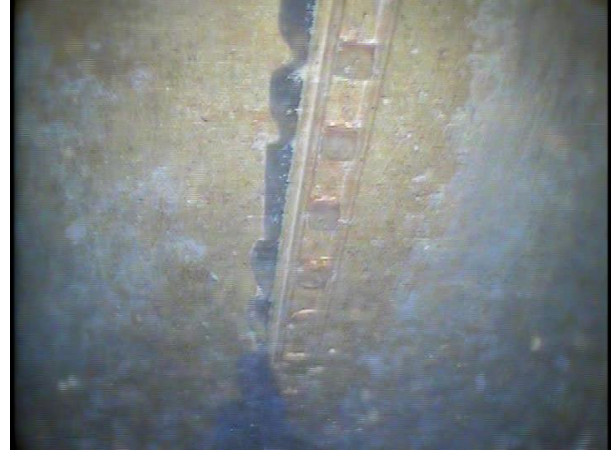
Summary: The galvanized interior wall was found in good condition with 2% surface corrosion noted.

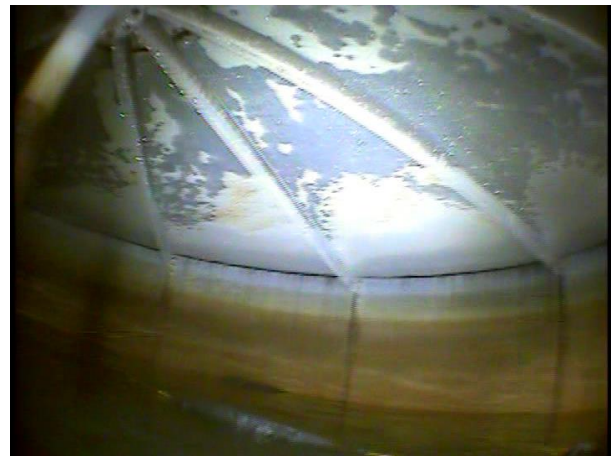
Summary: The galvanized interior roof was found in good condition with de-alloying present on the hardware and 5% surface corrosion noted.

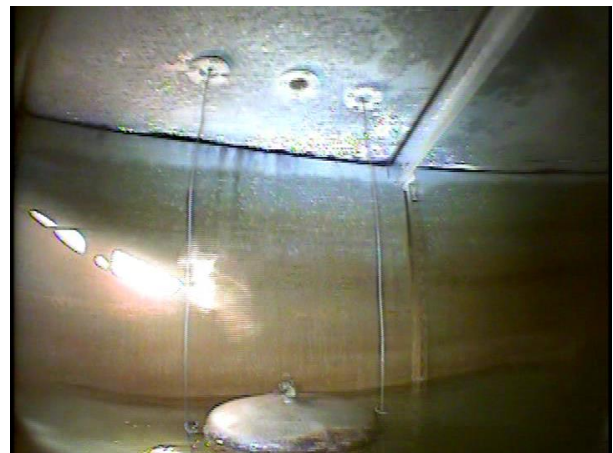
Summary: The float was found in good condition but it was not connected to a cable.

No cable

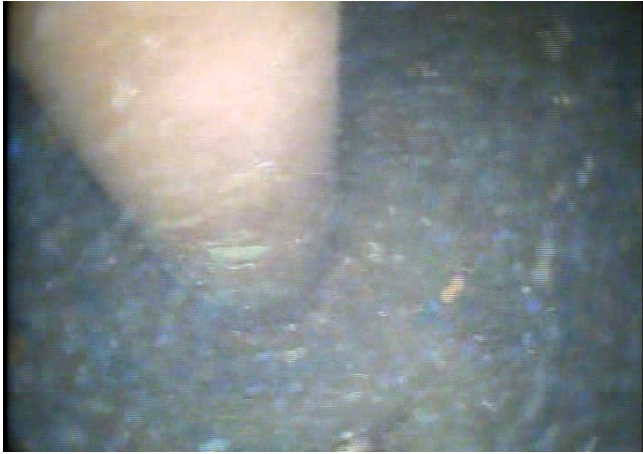
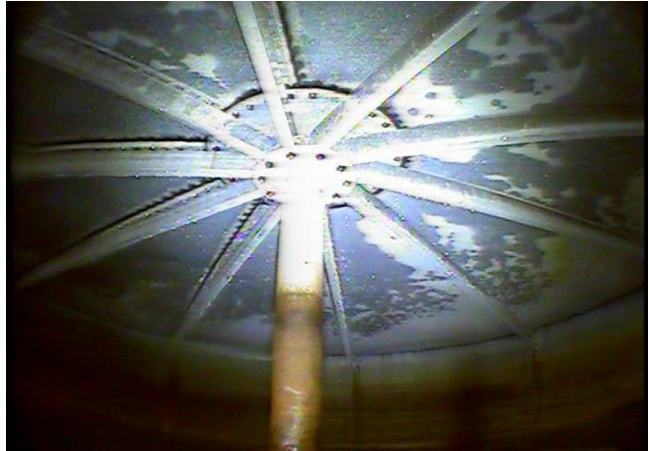
Summary: The galvanized support column was found secure and in good condition with small rust nodules present and 5% surface corrosion noted.

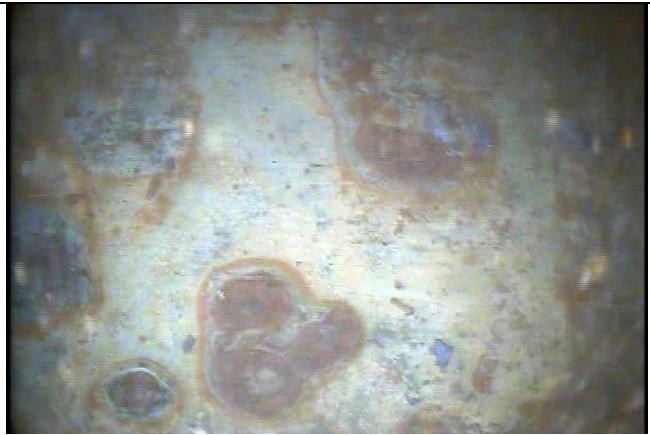
Summary: The uneven floor was found in poor condition with heavy staining, pitting and 95% rust noduling & surface corrosion noted. The hardware was also full of rust nodules. There were large rust nodules present that the diver was hesitant to open to check the depth of the pitting because he felt there was a potential for starting a leak.

Rust noduling

1. Due to the heavy rust noduling on the lower portion of the tank, it is recommended that the tank be replaced. While it remains online, it is suggested that epoxy be applied to the critical areas in the tank. (1 day)
