**Inspection Report for
Apple Valley Heights CWD
Apple Valley, CA**

**20KG Steel On-Grade
Middle Tank**

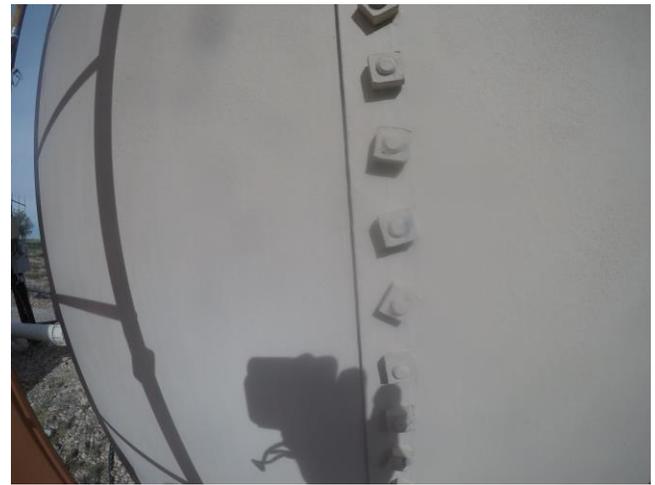
Overflow Structure Condition

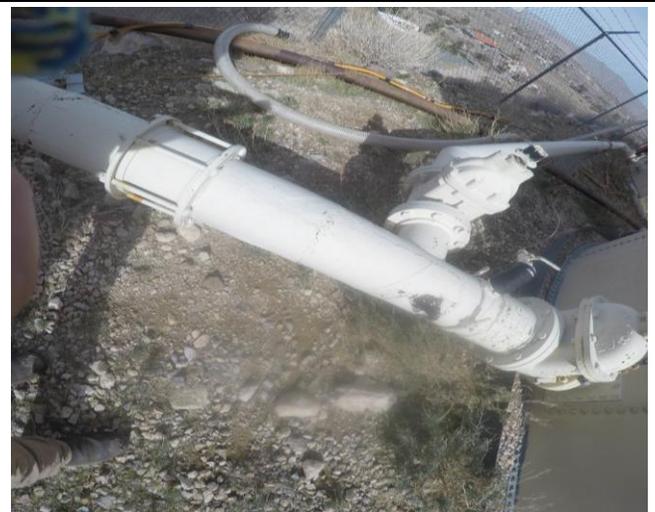
Summary: The overflow was found in poor condition with heavy oxidation, corrosive staining, cracking and 3% uniform surface corrosion & intergranular corrosion noted. There are also holes in the pipe.

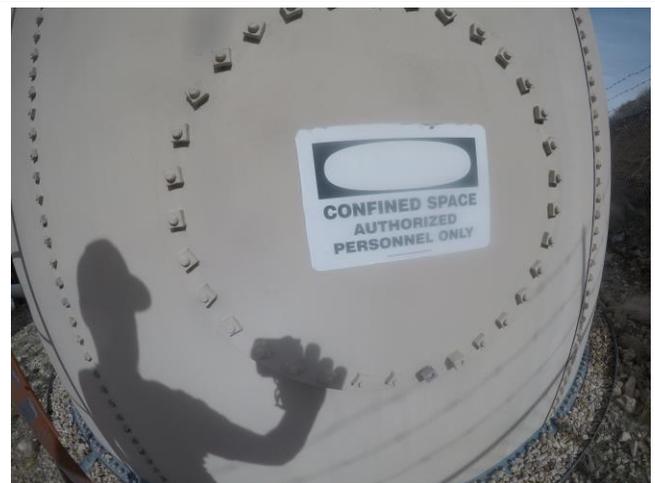
Water Level Indicator Condition

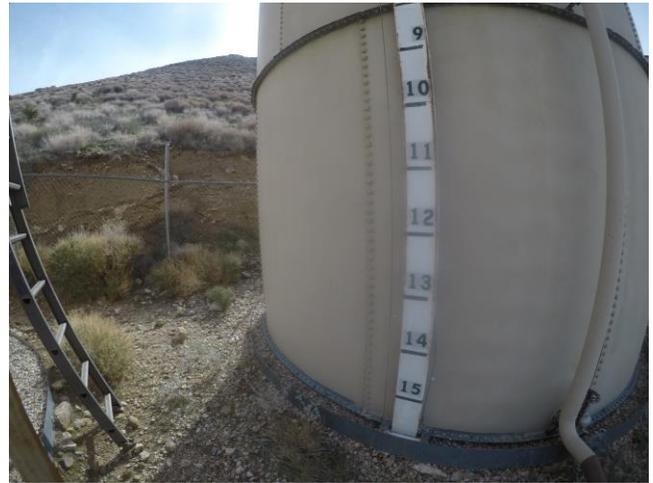
Access Ladder Condition

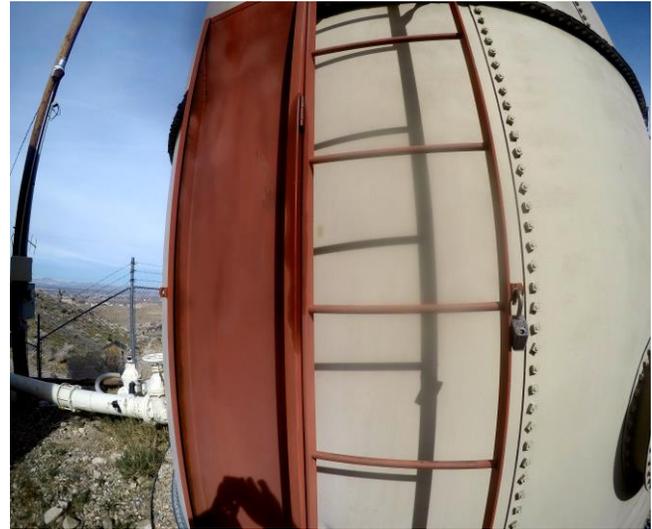
Summary: The ladder was found secure, OSHA approved and in good condition with minor oxidation, heavy chalking and 0.3% uniform surface corrosion noted.

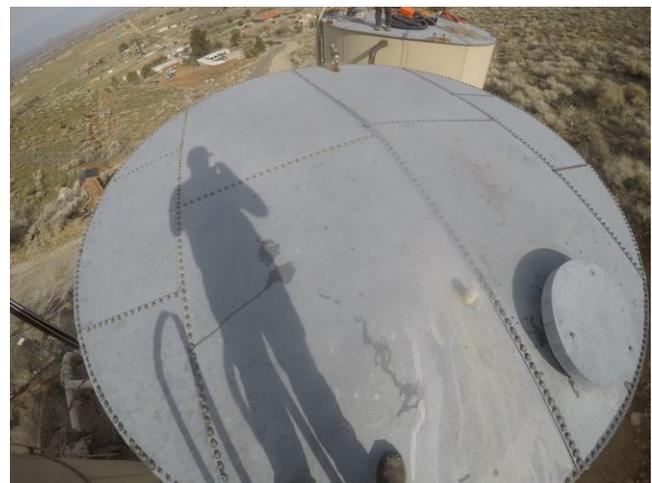
Access Hatch Condition

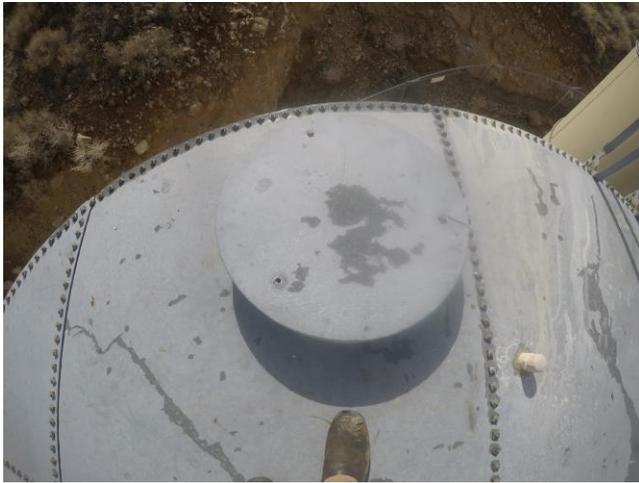
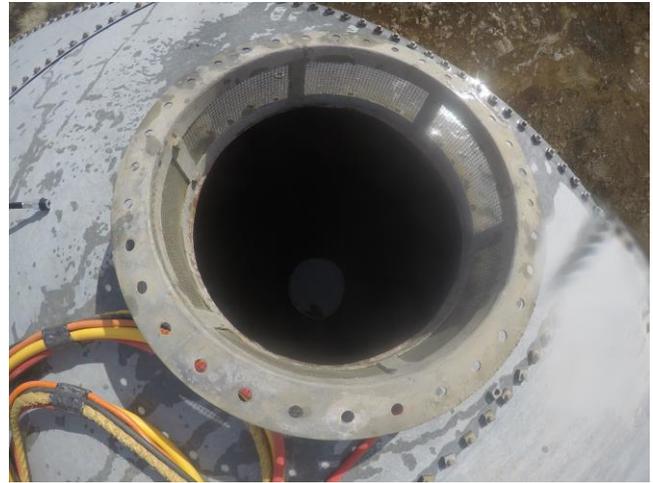
Summary: The hatch, which also serves as the vent, was found bolted shut with no gasket present and in good condition.

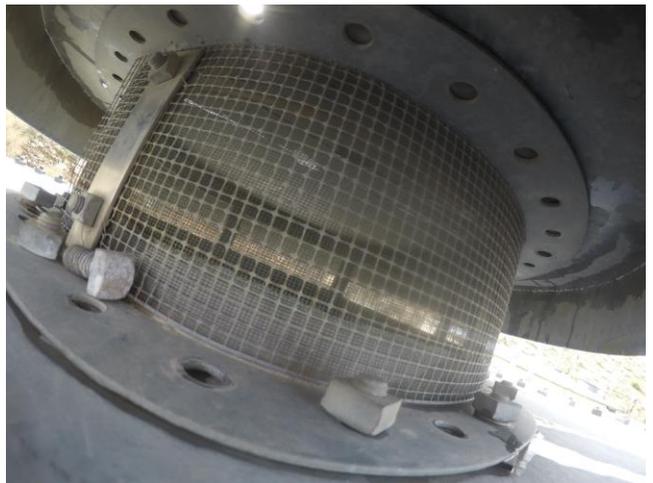
Summary: The vent, which is located on the hatch, was found in good condition with minor oxidation noted.

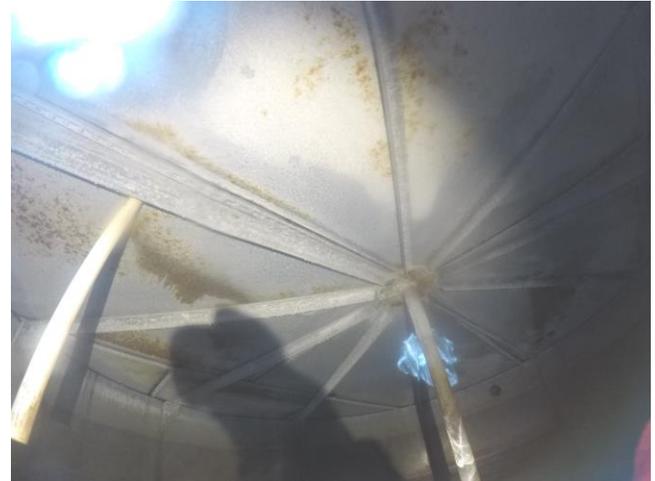
Summary: The interior roof was found in good condition with minor corrosive staining, minor to moderate oxidation and 0.01% uniform surface corrosion noted.

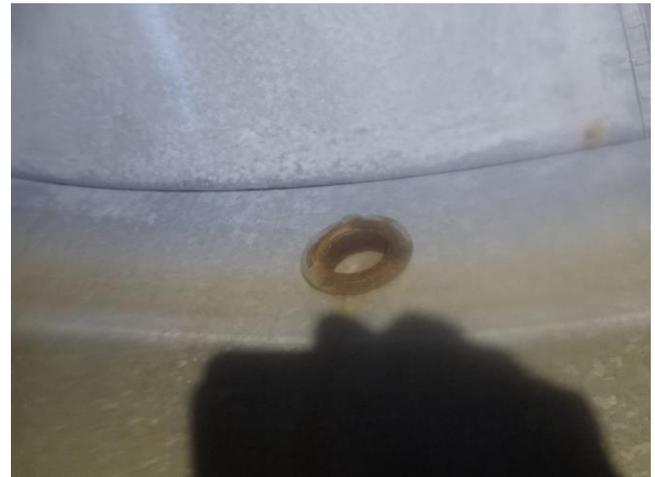
Wall Panel Condition

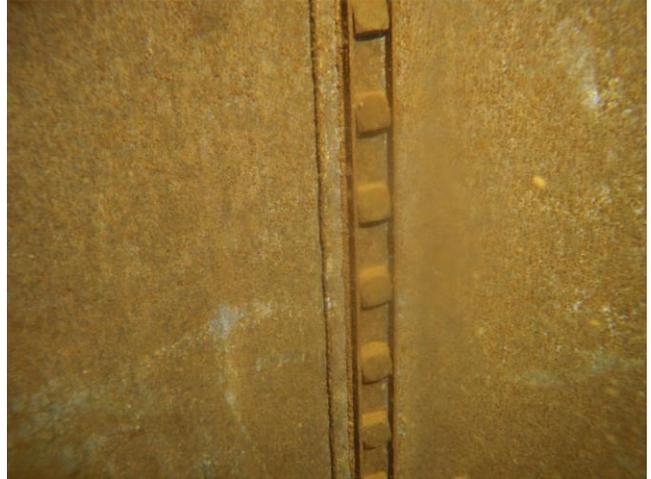
Summary: The interior wall was found in good condition with minor corrosive staining, heavy sediment staining and 0.03% uniform surface corrosion & rust noduling noted.

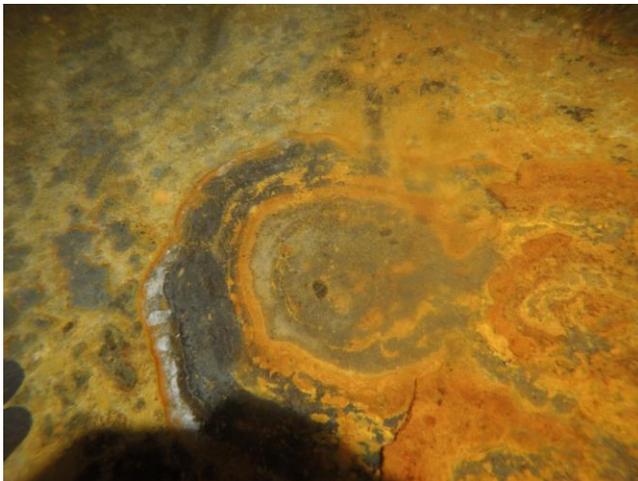
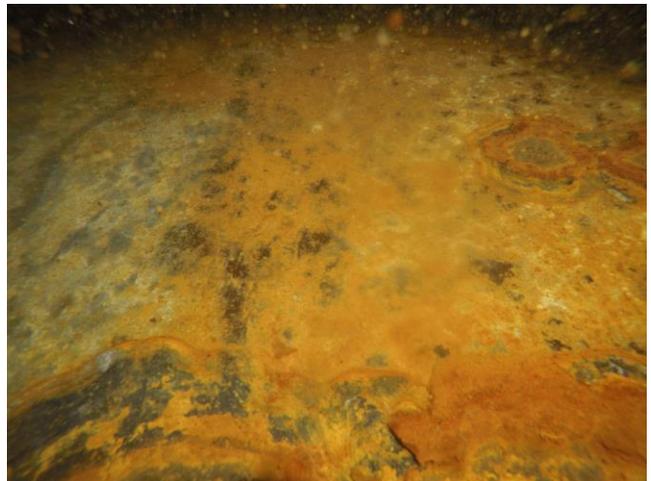
Summary: The floor was found in fair to poor condition with heavy sediment & corrosive staining, 1/16 inch deep pitting, 33% rust noduling and greater than 50% uniform surface corrosion noted.

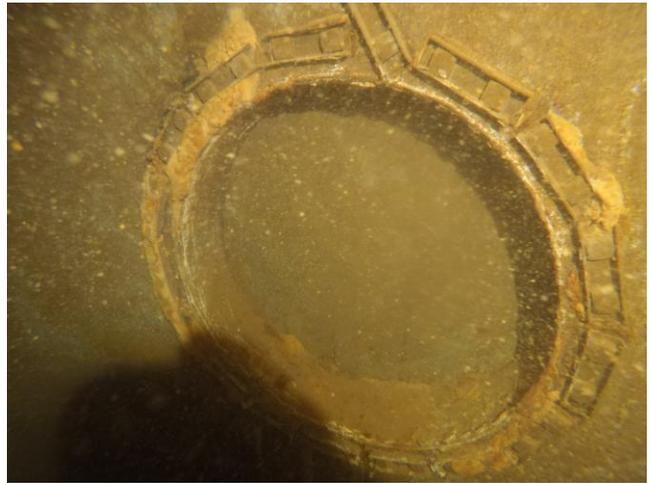
Inlet and Outlet Condition

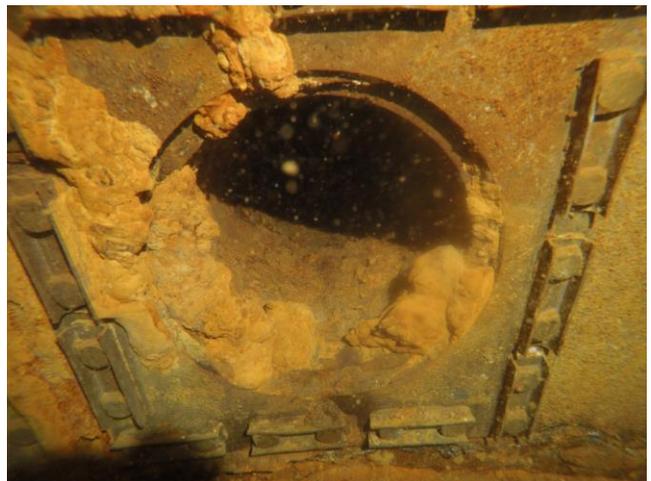
Summary: The common inlet/outlet was found in good to fair condition with heavy sediment & corrosive staining, 1/16 inch deep pitting, 10% rust noduling and 0.3% uniform surface corrosion noted.

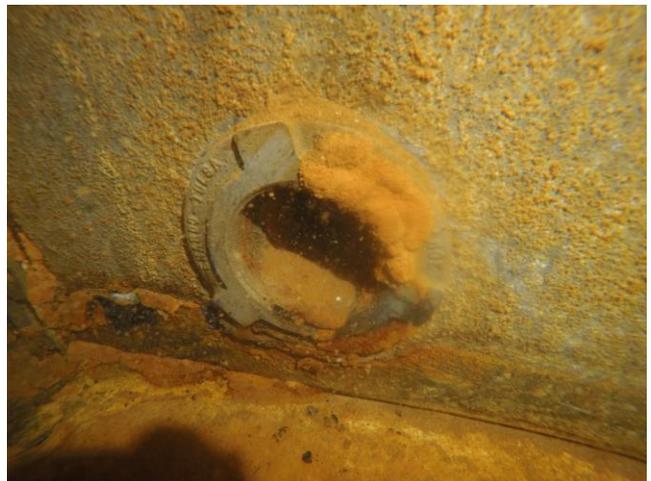
Summary: The drain was found in good to fair condition with minor to moderate corrosive & sediment staining and 0.3% rust noduling noted.

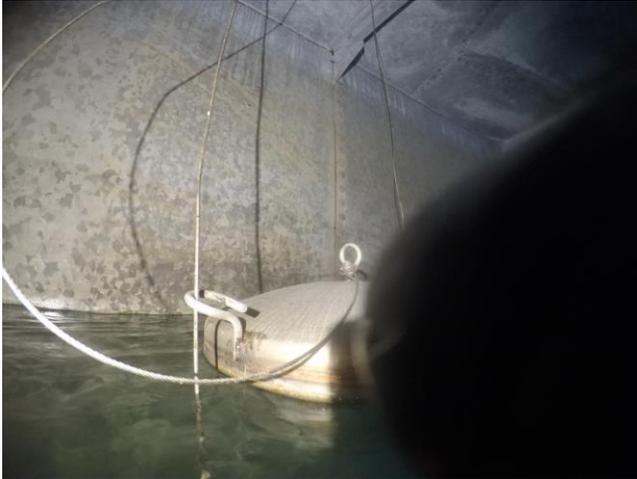
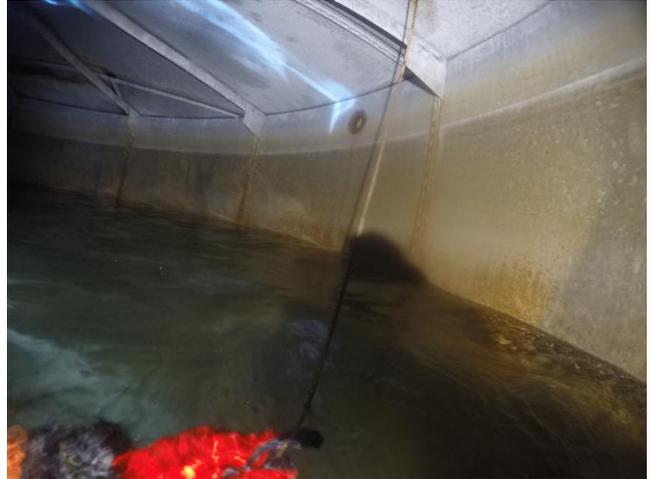
Support Column Condition

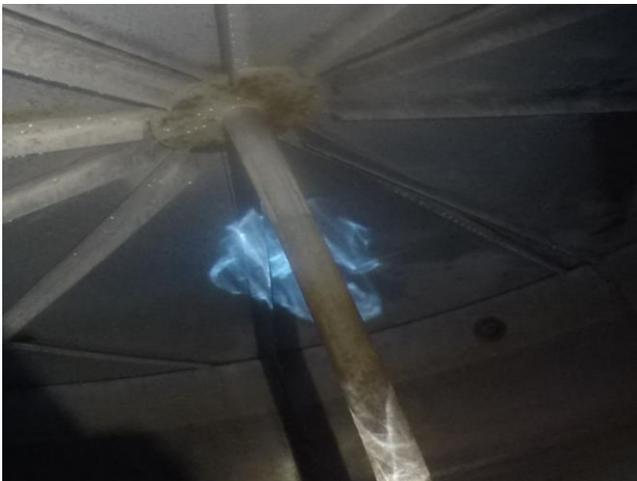
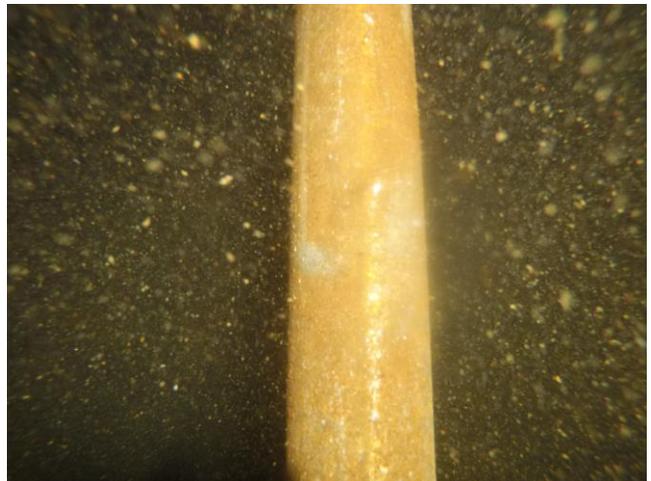
Summary: The support column was found secure and in good condition with minor sediment staining, heavy corrosive staining, 0.01% rust noduling and 0.1% uniform surface corrosion noted.
